**HAZARD RANKING SYSTEM (HRS)  
DOCUMENTATION RECORD - REVIEW COVER SHEET**

Name of Site: Jackpile-Paguate Uranium Mine

## HRS DOCUMENTATION RECORD

Date Prepared: March 2012

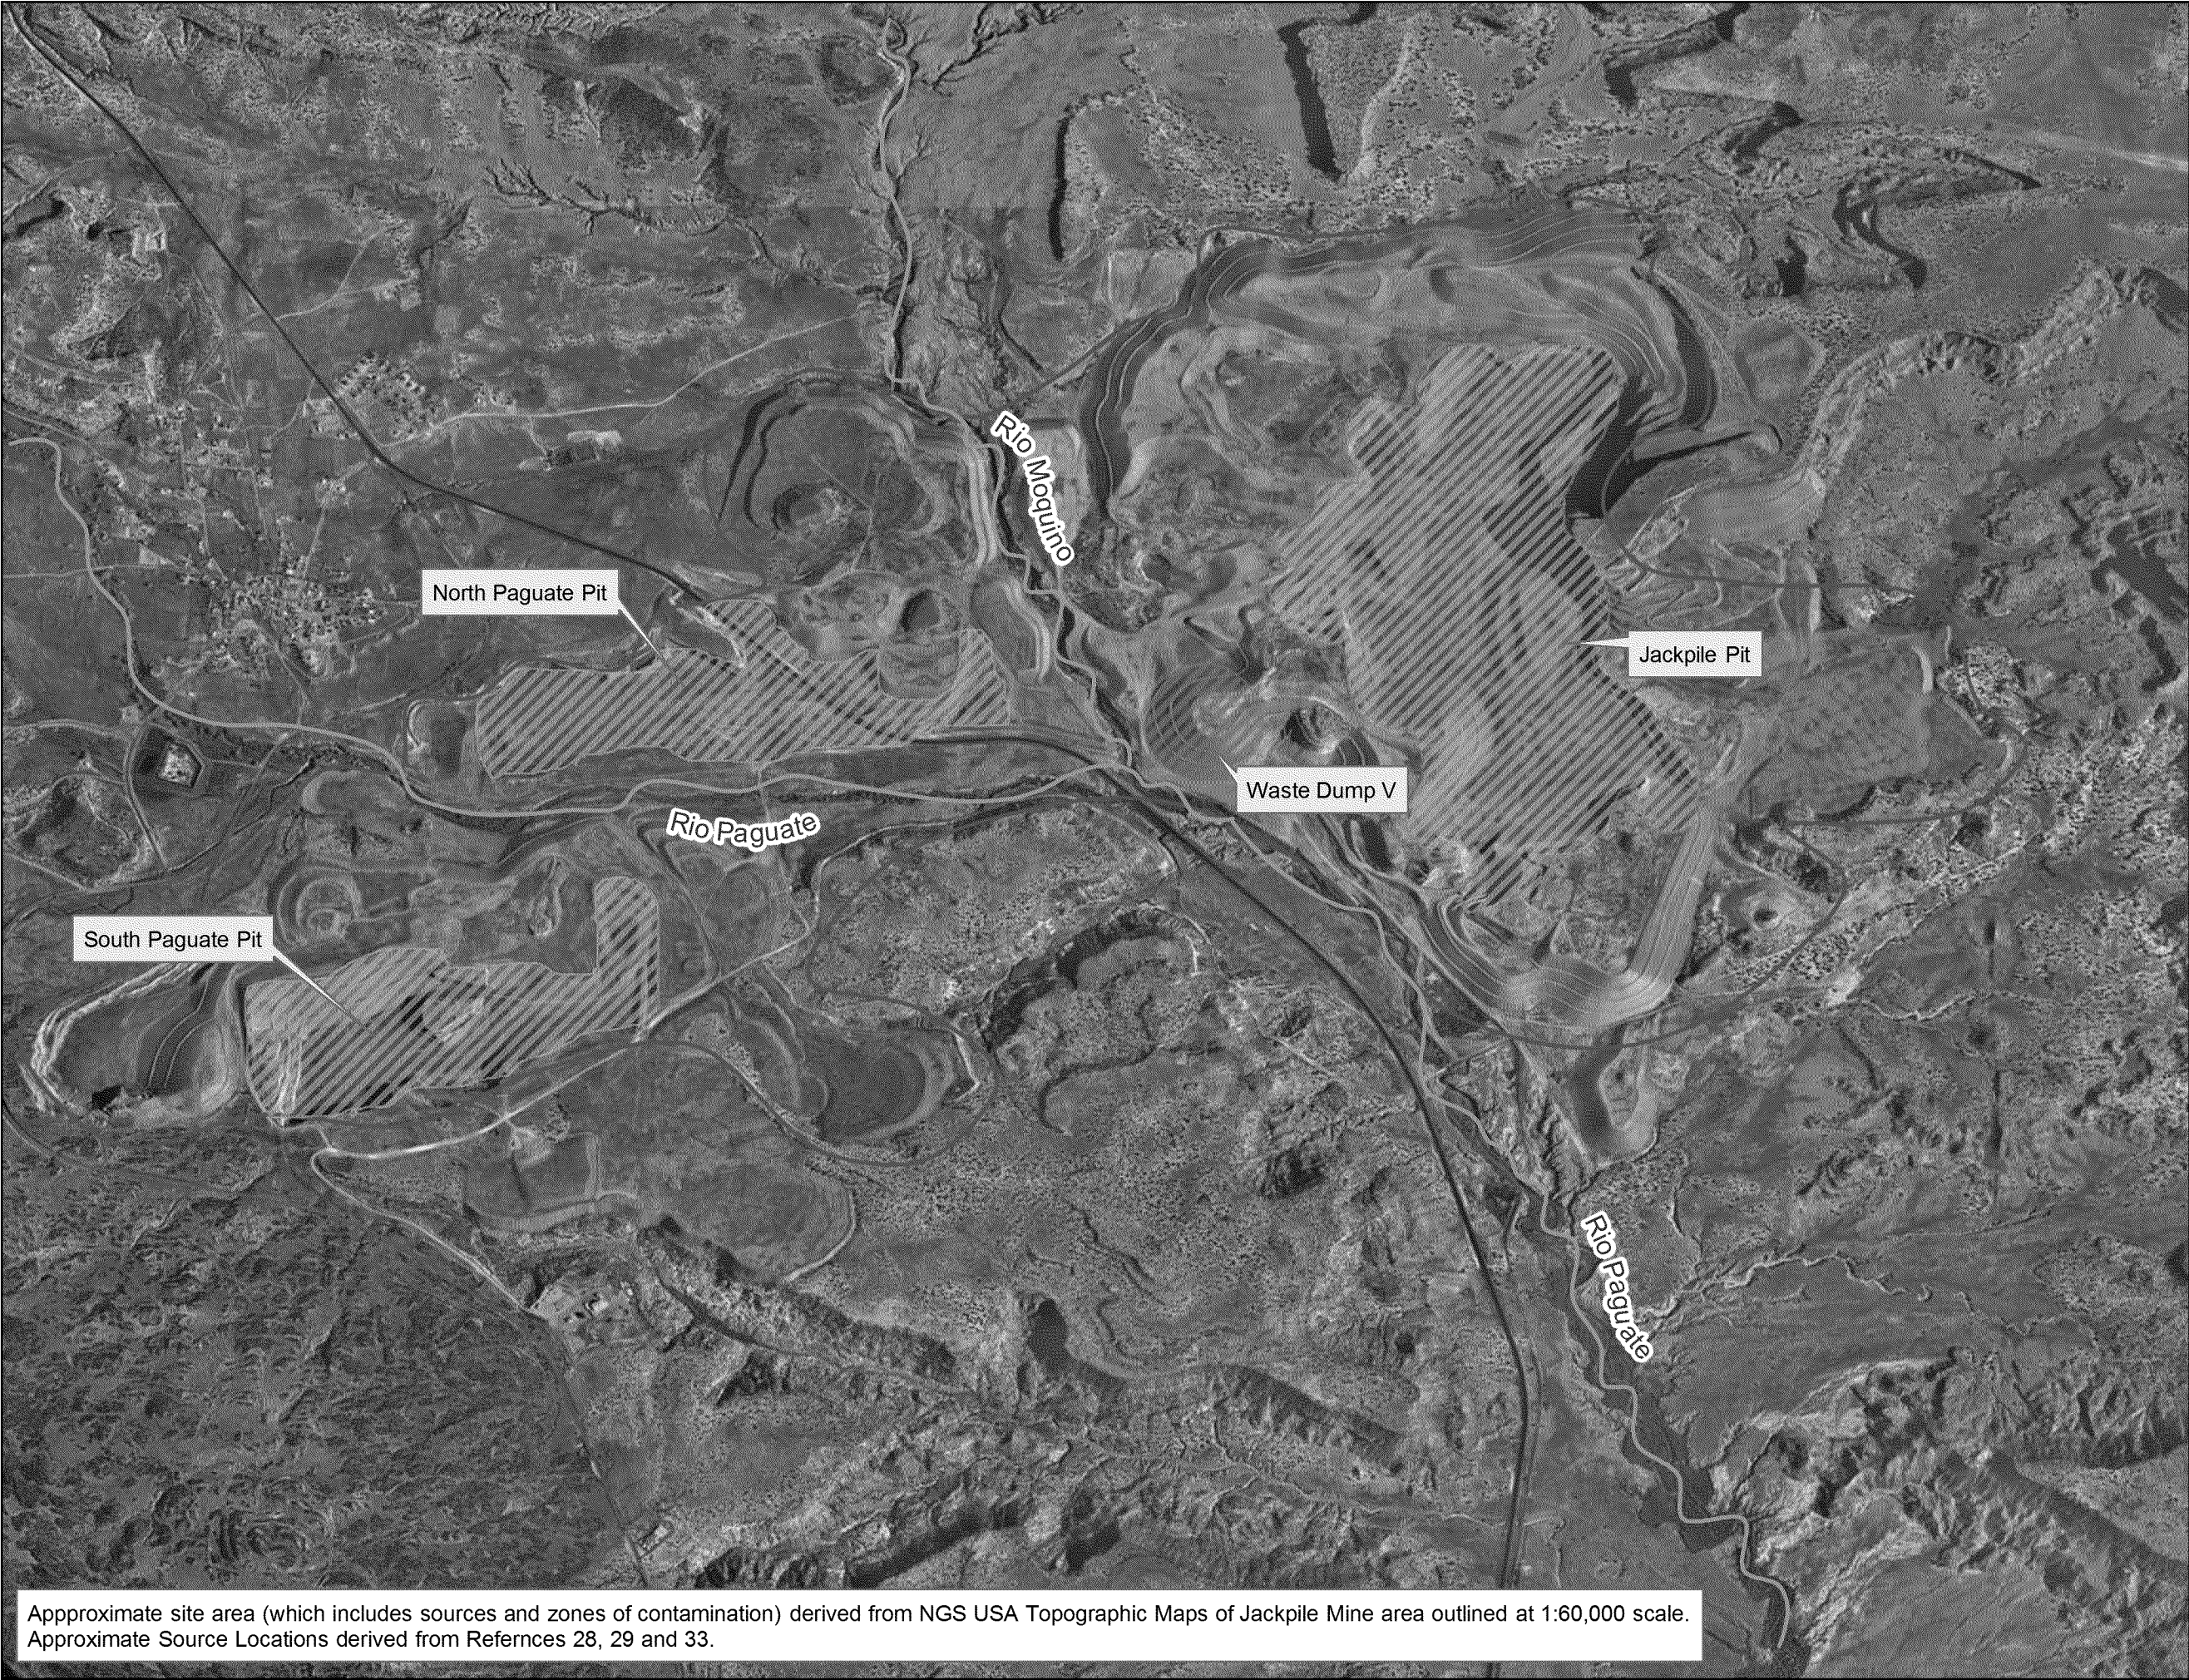
Approximate site area (which includes sources and zones of contamination) derived from NGS USA Topographic Maps of Jackpile Mine area outlined at 1:60,000 scale. Approximate Source Locations derived from References 28, 29 and 33.

Mining operations at the Jackpile-Paguate Uranium Mine resulted in approximately 2,656 acres of surface disturbance, of which the open pits accounted for approximately 1,015 acres (Ref. 4, pp. 24, 59). The location of this source is depicted on Figure A-2 and features of the open pit can be found in References 28 and 29.

Mining operations at the Jackpile-Paguate Uranium Mine resulted in approximately 2,656 acres of surface disturbance (Ref. 4, pp. 56, 59). The only waste dump sampled and evaluated for this source is identified as Waste Dump V (Ref. 29). The mine contained 32 waste dumps that account for approximately 48 percent of the disturbed area (Ref. 4, p. 61). The location of Waste Dump V is depicted on Figure A-2 and the location of all the waste dumps can be found in References 28 and 29.

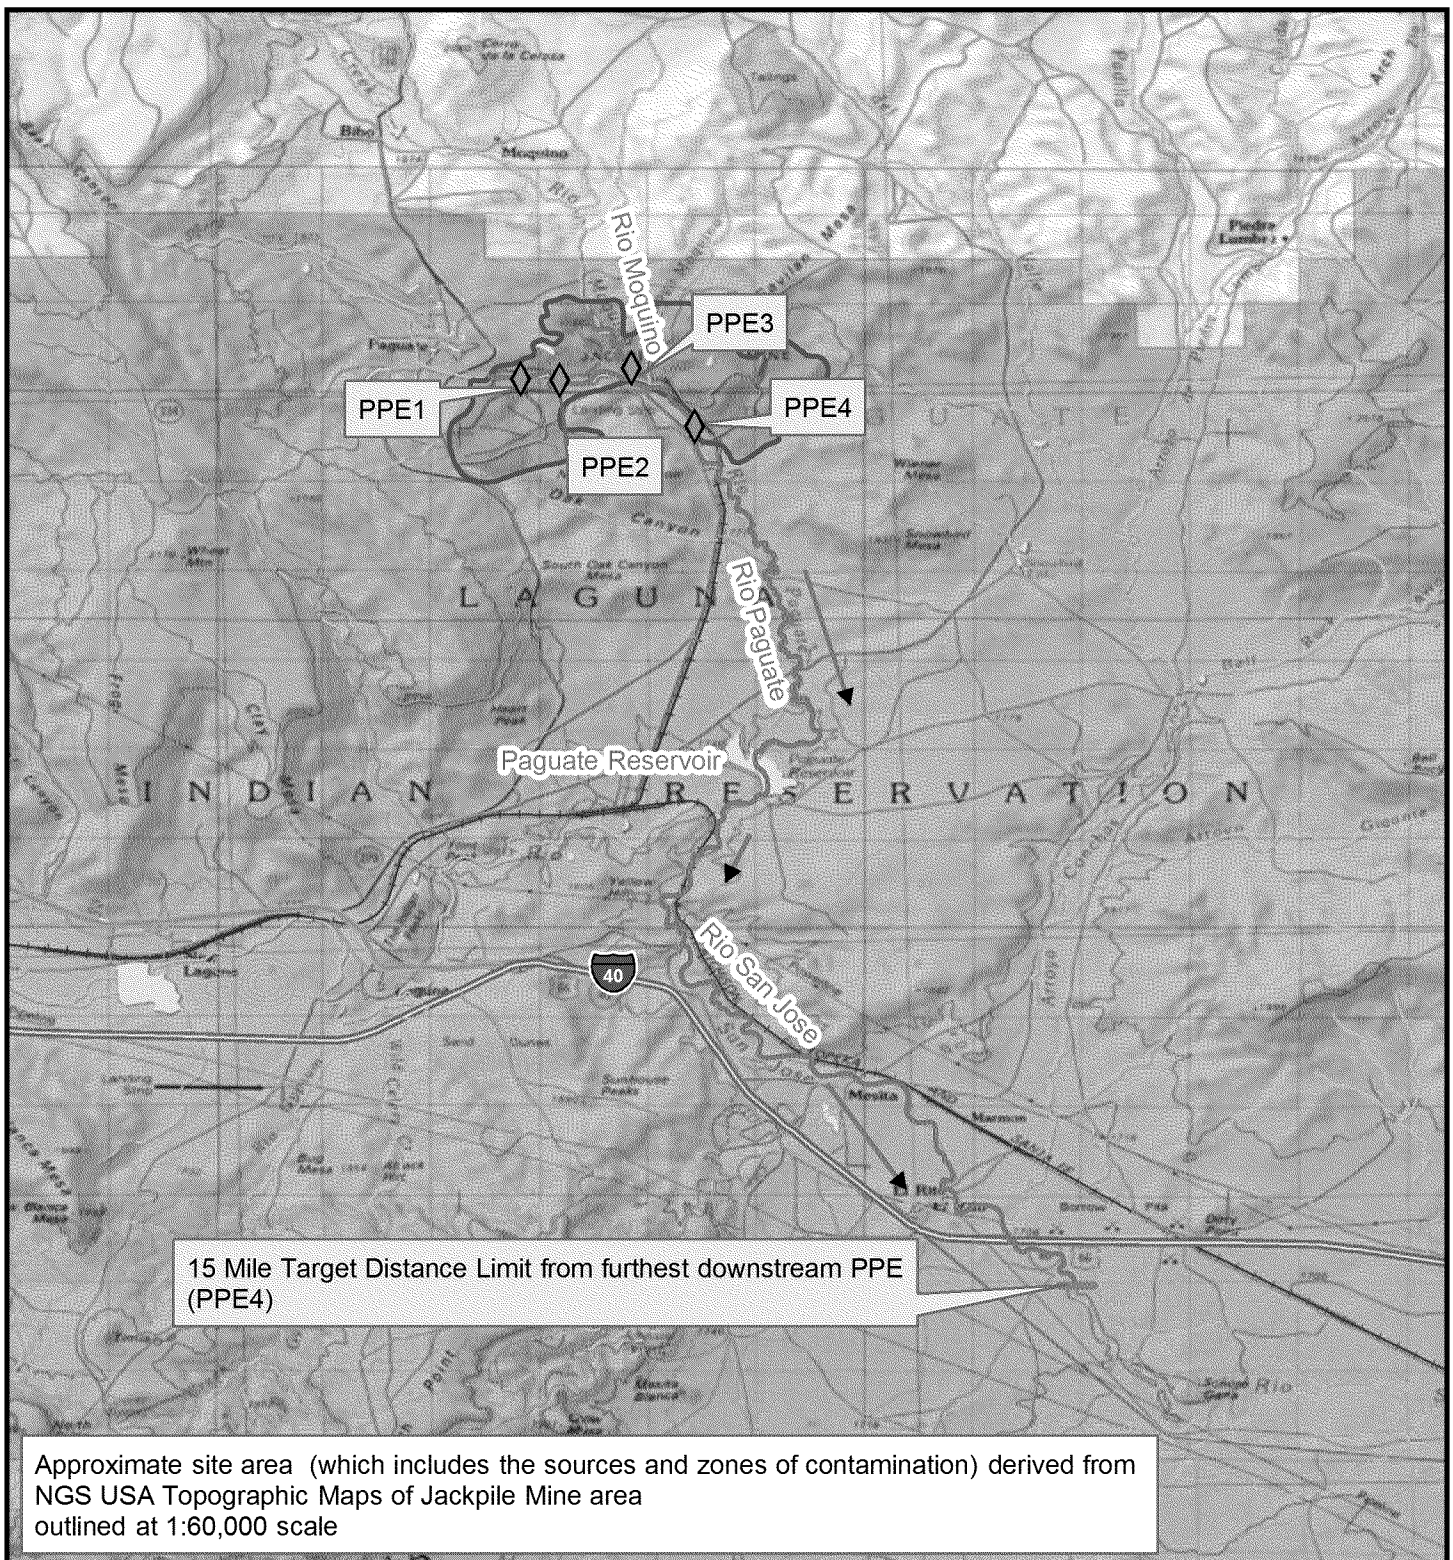
File: Wsdtx03\TIGIS\_Projects\brownm\Jackpile\HRS\Figure A-4, 23-September-2011, brownm

- Approximate Mine Boundary
- Probable Point of Entry (PPE)
- Surface Water (SW) Pathway
- Target Distance Limit (TDL)
- Flow Direction

The hazardous substance migration path includes the in-water segment that hazardous substances would take as they migrate away from sources at the facility (Ref. 1, Section 4.1.1.1). The hazardous substance migration path for in-water segments for the sources are described below. The surface water pathway is presented on Figures A-3 and A-4.

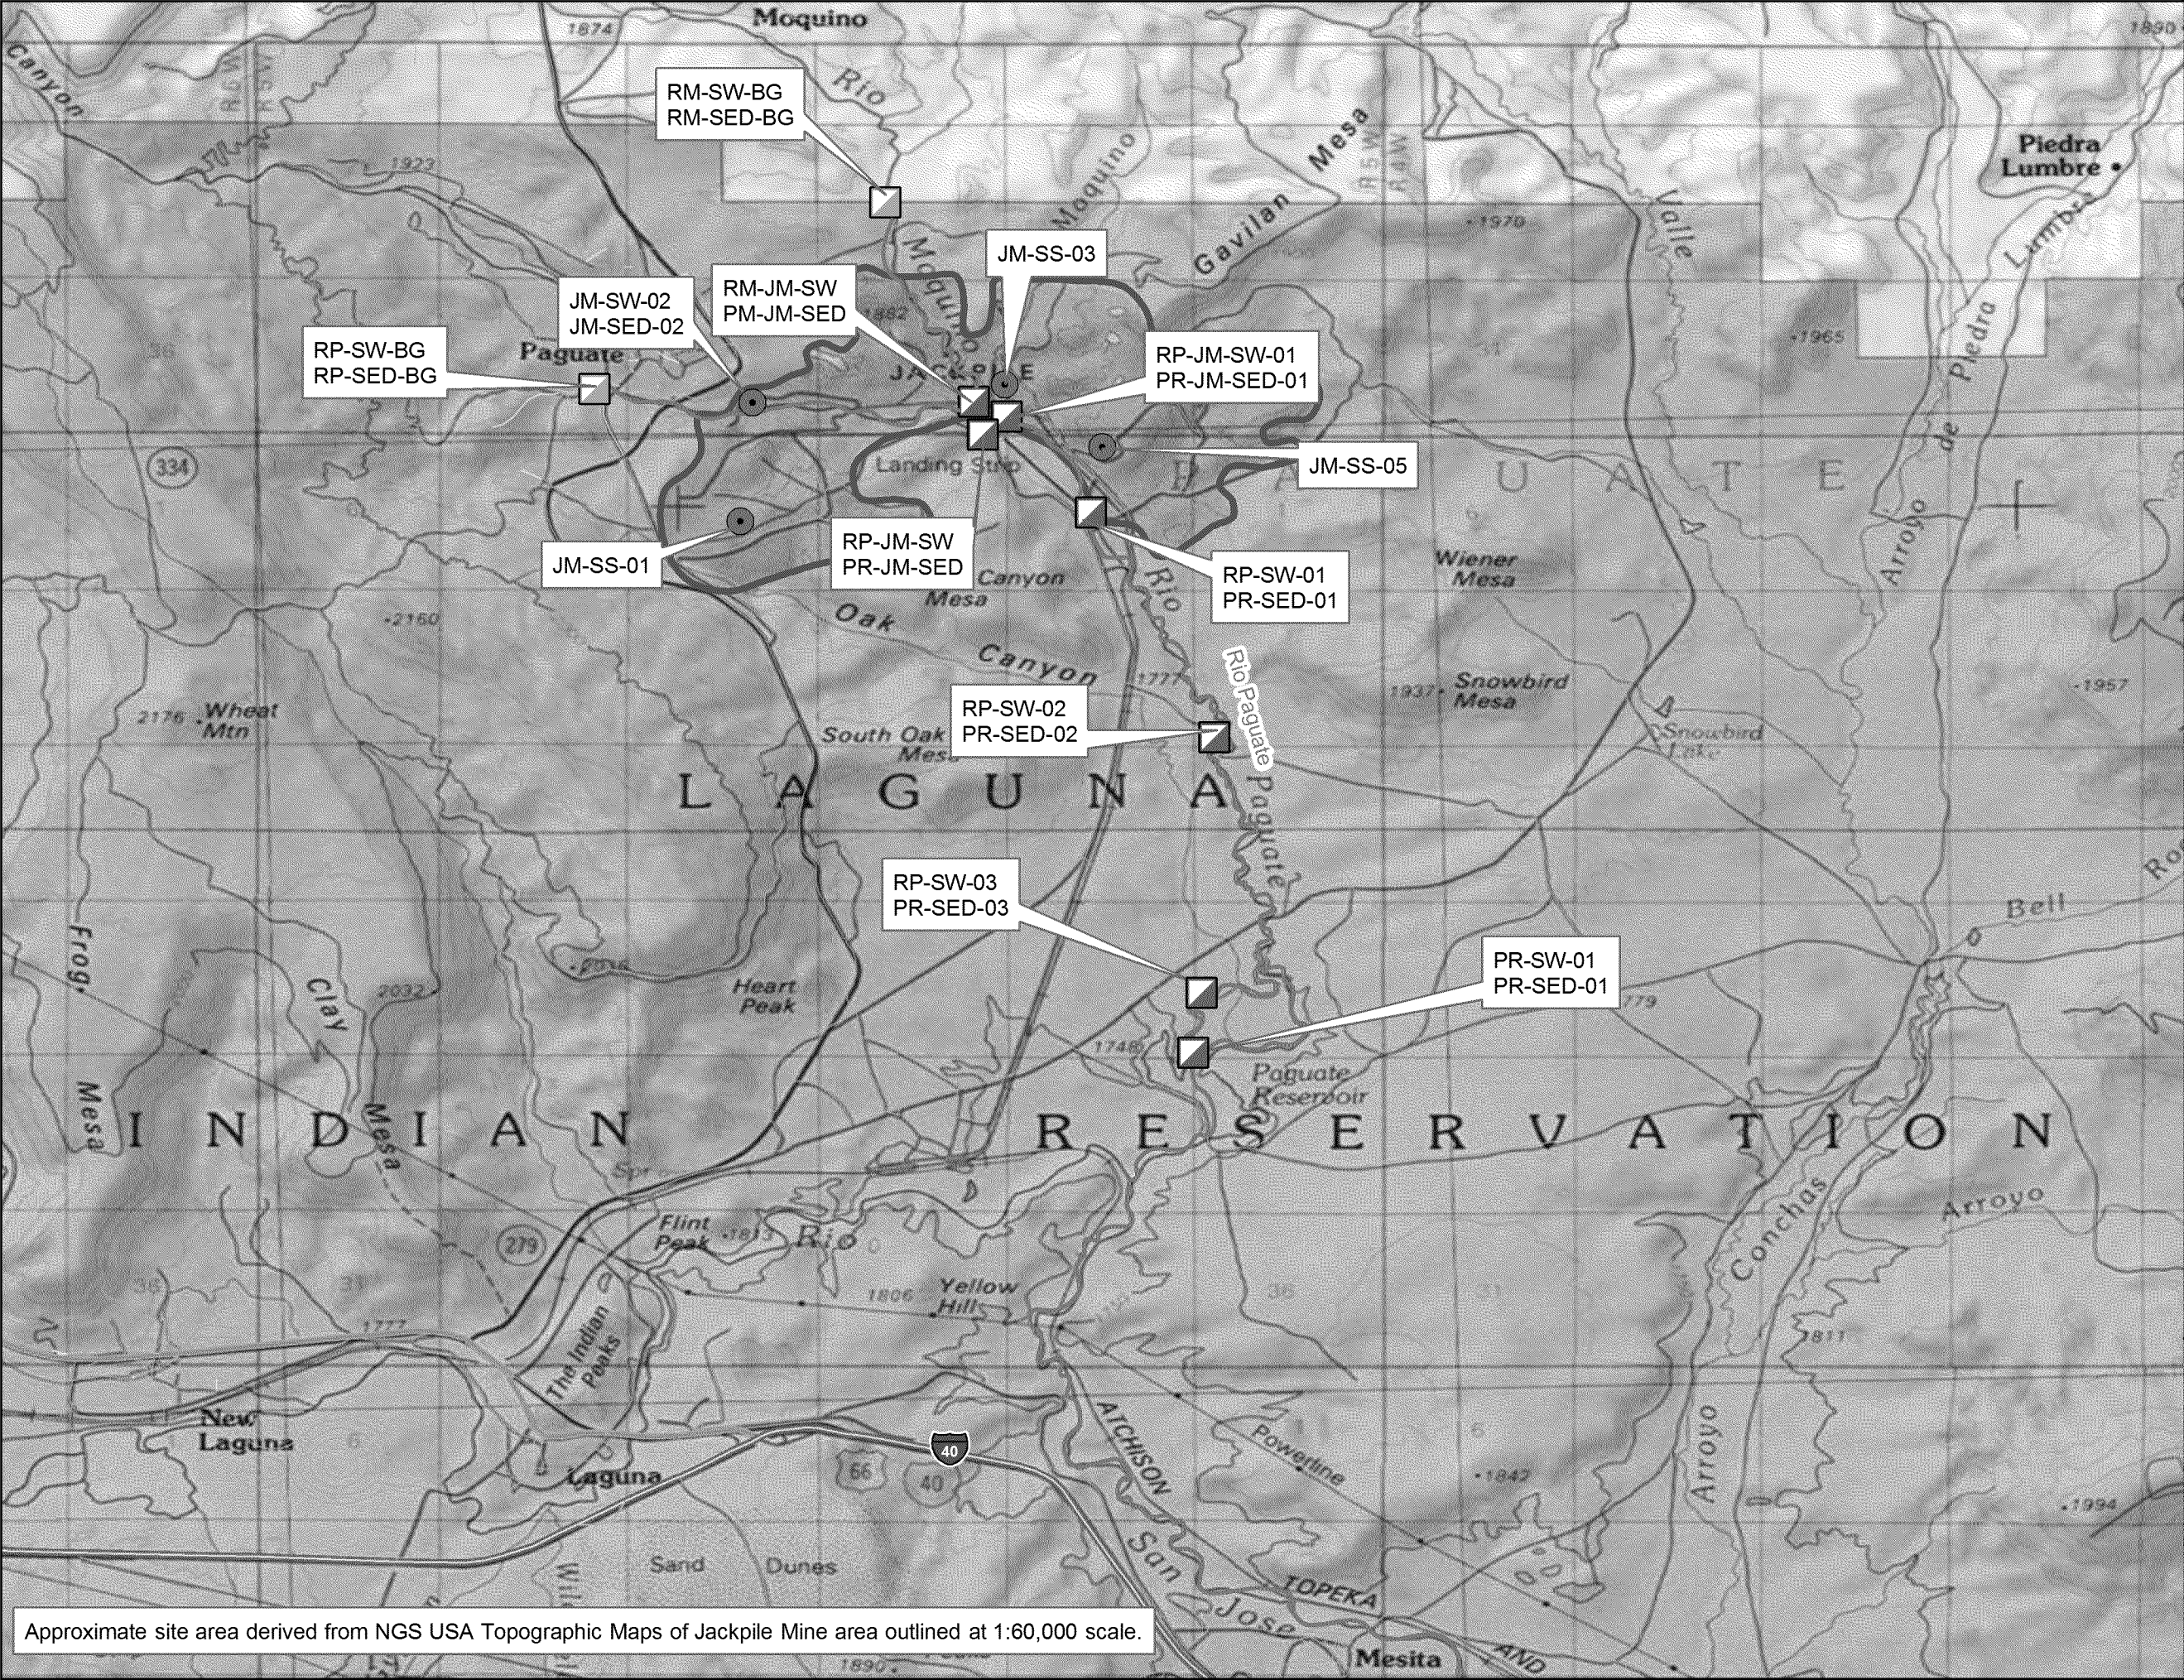
- LEGEND**
- Approximate Mine Boundary
  - Surface Water (SW) Pathway
  - SW and Sediment Sample Location
  - SW and Sediment Background Sample Location
  - Source Sample Location
  - Sample Name

Approximate site area derived from NGS USA Topographic Maps of Jackpile Mine area outlined at 1:60,000 scale.

During the March 2010 SI sampling activities, sample JM-SS-03 was collected on the bank of the Rio Moquino and close to surface water sample RM-JM-SW (Figure A-5A; Ref. 19, pp. 21, 22; Ref. 30, pp. 76, 77). According to Laguna officials, the river banks were not reclaimed and source materials are present there (Ref. 19, p. 5). Source sample JM-SS-03 was collected during draught conditions and therefore was not in direct contact with the surface water. However, after rain events, the Rio Moquino would contain water such that sample location JM-SS-03 would be in direct contact with the surface water (Ref. 19, pp. 4, 6, 7). Sample JM-SS-03 contained elevated concentrations of total uranium at 127 ppm (Ref. 20, pp. 172, 1210; Ref. 26, 1 to 3). The surface water samples collected within the Rio Moquino adjacent to this sample contained total uranium at 16.8 ppb, 109 ppb and 78.9 ppb (Ref. 19, p. 22; Ref. 20, pp. 22, 75, 1190, 1219; Ref. 25, pp. 1 to 5; Ref. 26, pp 1 to 3; Ref. 35, pp. 96, 772-773, 1587). These concentrations were greater than background concentrations found within Rio Moquino (sample RM-SW-BG) (Ref. 19, p. 18; Ref. 20, pp. 18, 70, 557, 580,711,782,1203; Ref. 25, pp. 1 to 5, 45 to 49; Ref. 26, pp. 1 to 3; Ref. 35, pp. 87-88, 774, 1587).
